Stress Corrosion Cracking in 316L Stainless Steel Bellows of a Pressure Safety Valve

Bijayani Panda, M. Sujata, M. Madan, S.K. Bhaumik

Council of Scientific and Industrial Research (CSIR), National Aerospace Laboratories,
Materials Science Division, Bangalore 560 017, INDIA

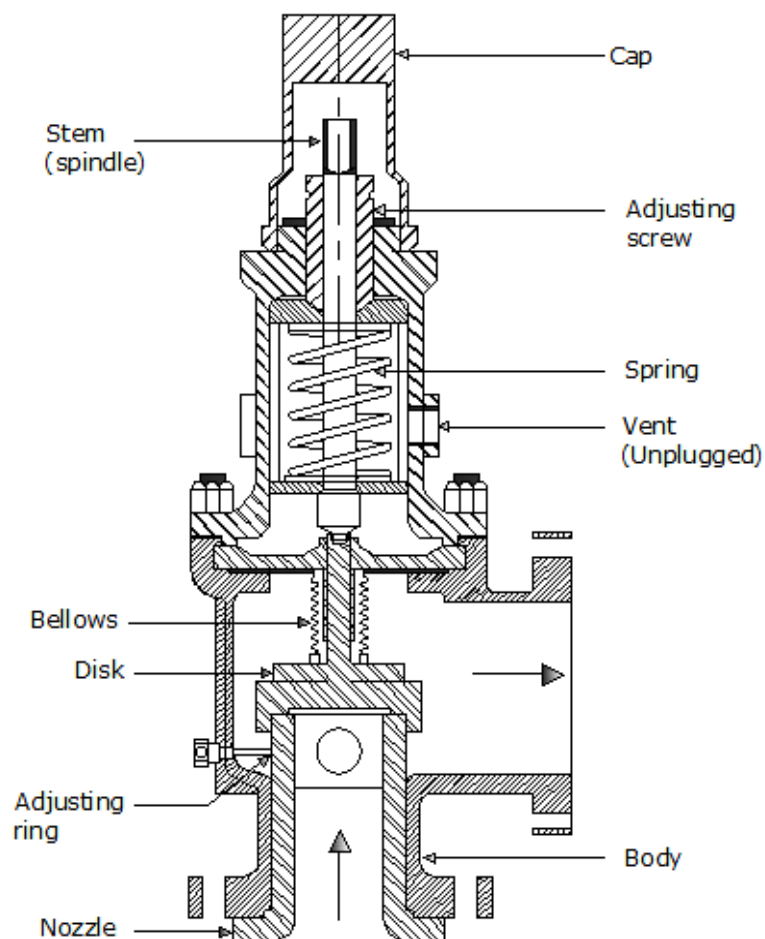
There was a series of failure of bellows installed in a PSV of a hydrocracker unit leading to leakage of process fluid. The first failure of the bellows took place after 13 years of service. After the first failure, the bellows was replaced by a new one. However, the failure continued to occur and in total, there were three consecutive failures in a span of one week duration. On-site inspection showed several cracks on the outer surface of the bellows. The operating pressure and temperature of the PSV were 1.6 kg/cm^2 and 100°C respectively. The construction of the PSV is illustrated schematically in Fig.1.

Figure 1 Schematic showing the bellows in the pressure safety valve (PSV) assembly
